## DODGE UTILITY

### Asset Details

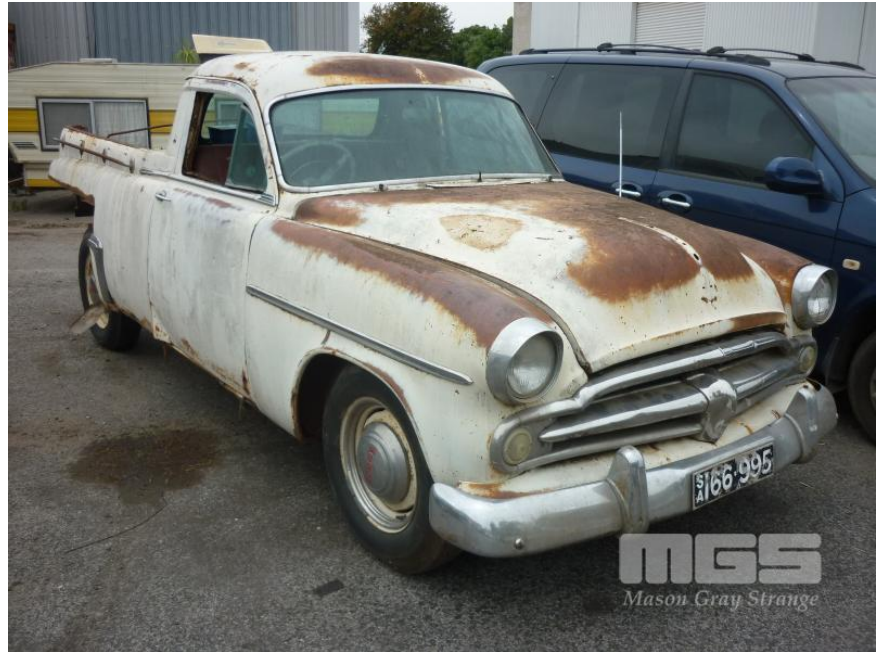
MISSING REAR PANELS, HOOD ORNAMENT IN OFFICE, SUIT WRECK OR RESTORATION

| Location | Damage |
|---|---|
| BODY | RUST THROUGHOUT |
